Inspection Limits, Baseline, & Sheet Pile Pair Numbering with NJDEP 2015 Aerial

Photo 1: High Bar Harbor Yacht Club

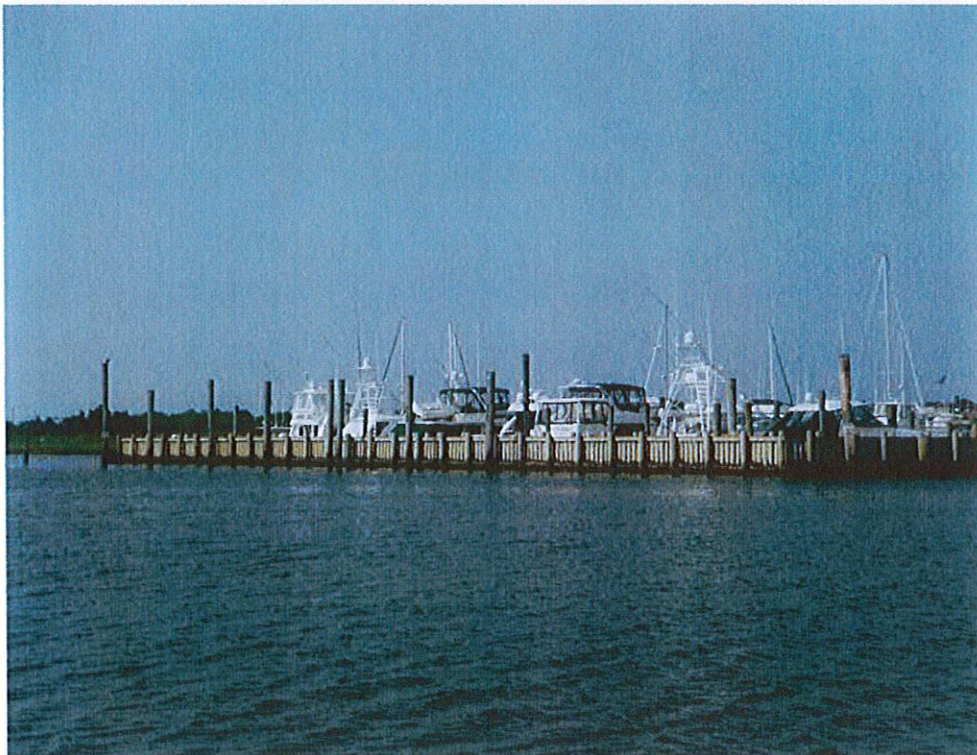
Photo 2: Overall view of northern section of new wave screen

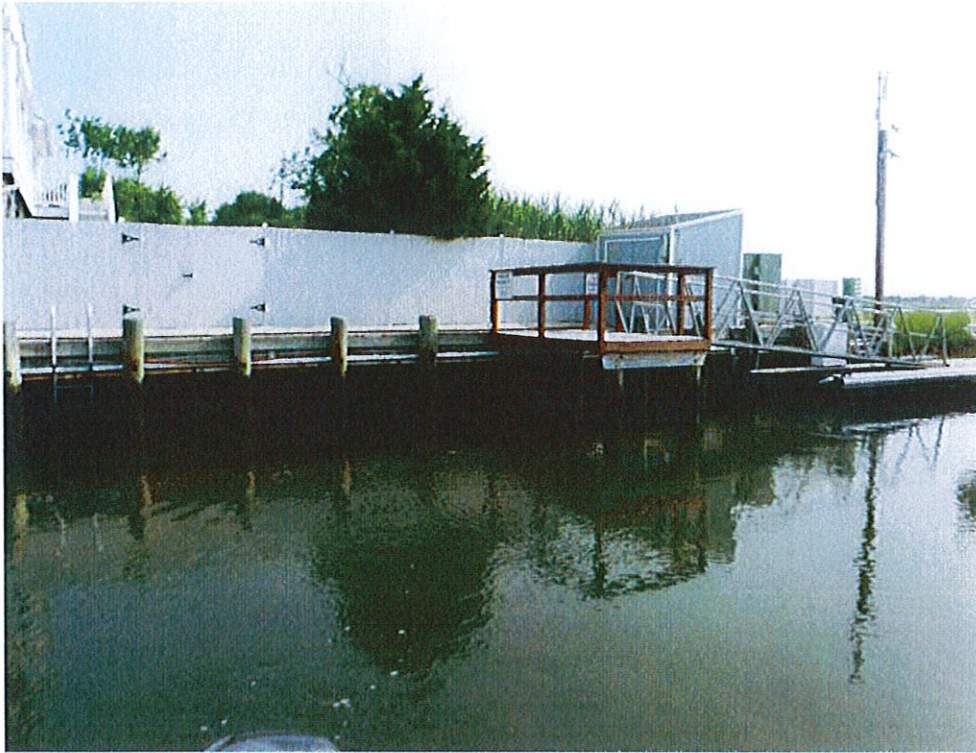
Photo 9: View of bulkhead east of C Dock

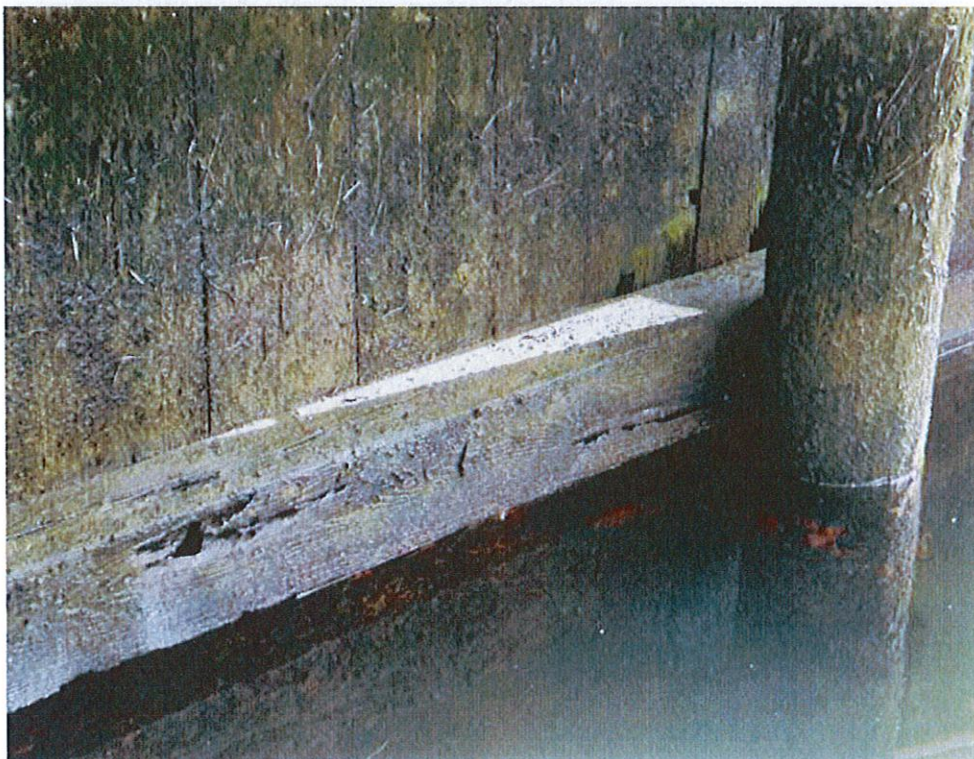
Photo 10: Wale that is east of C dock with heart rot

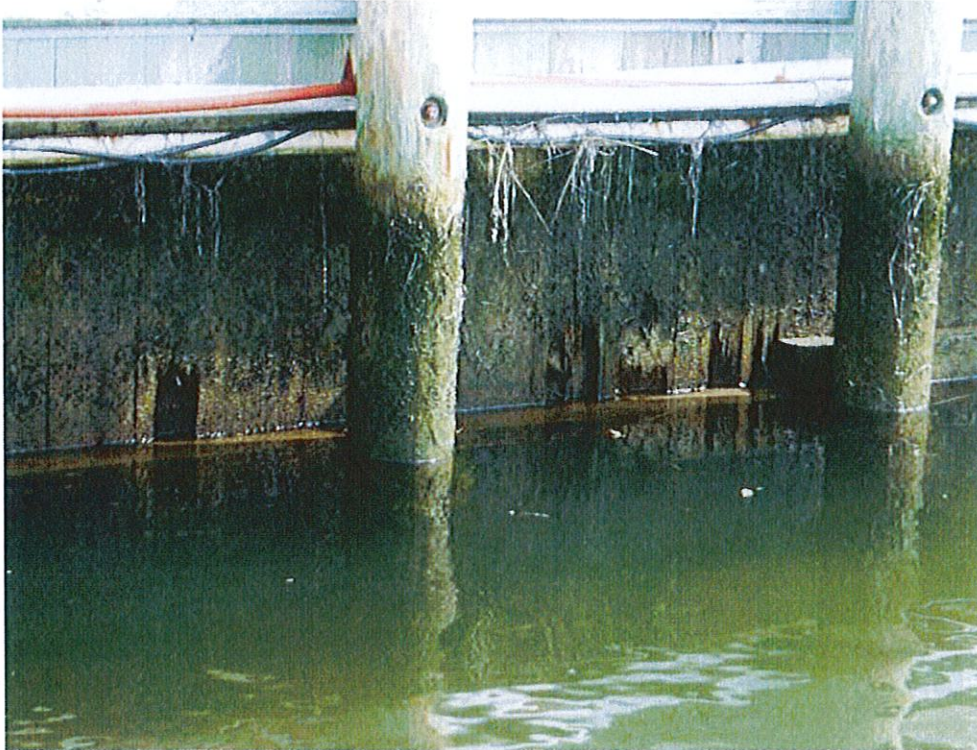
Photo 13: Deterioration of sheet piles and wales west of B Dock

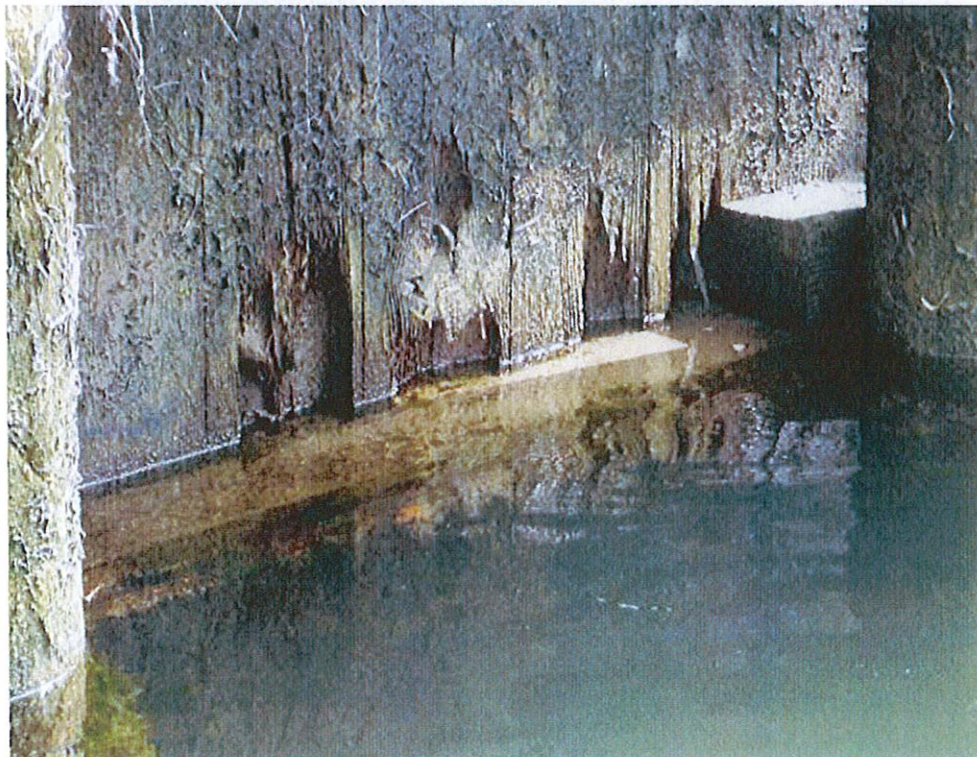
Photo 14: Close up of Photo 13 showing incipient holes in sheet pile and holes/heart rot in middle wale

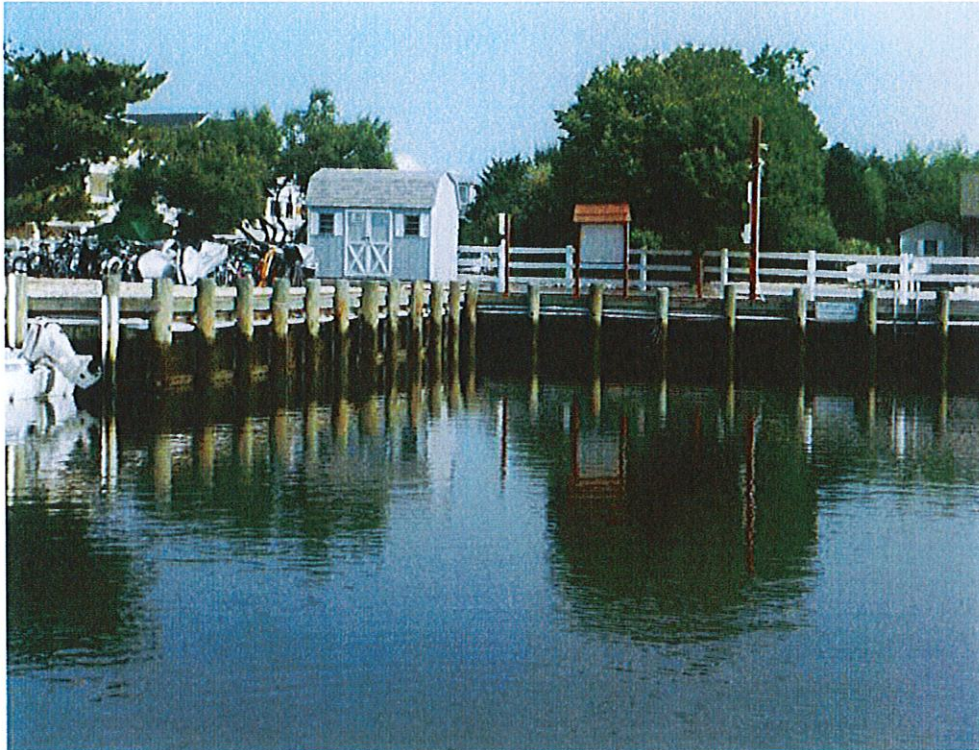
Photo 15: View of the northwest corner of the bulkhead

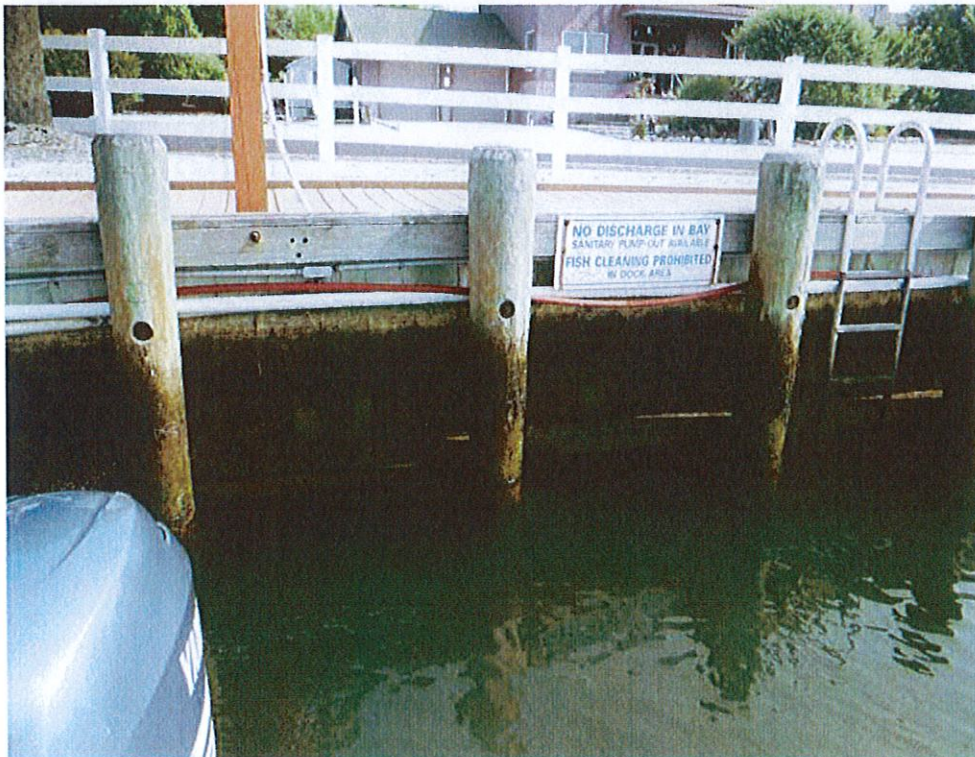
Photo 16: Typical safety ladder and view of the portion of bulkhead in the tidal zone

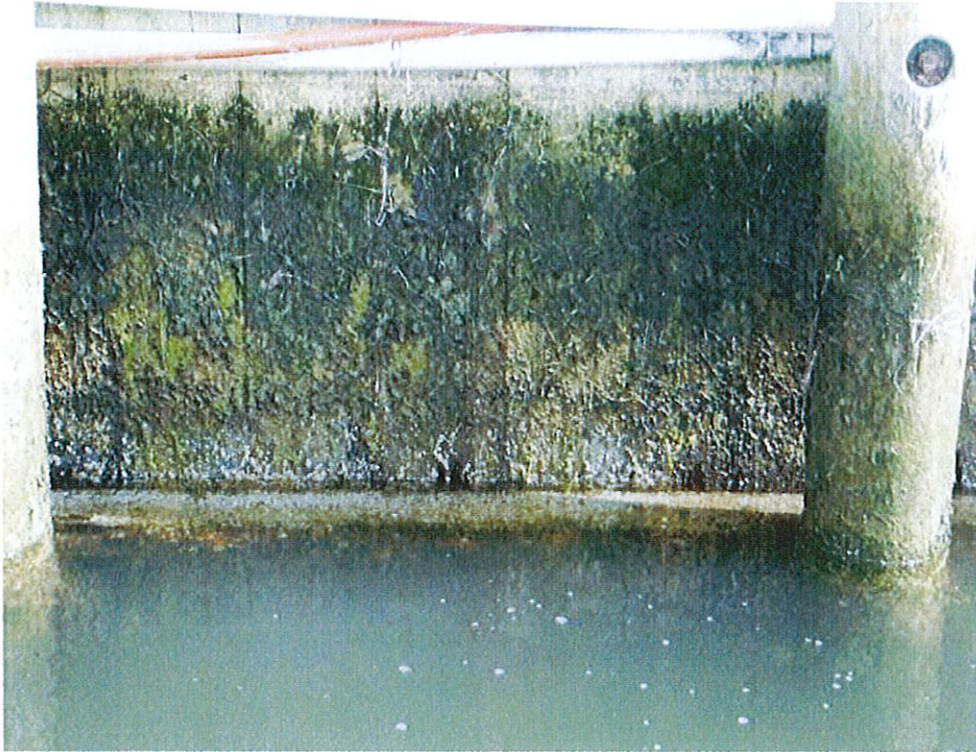
Photo 17: Deteriorated bulkhead with hole in sheet pile at north side near the northwest corner

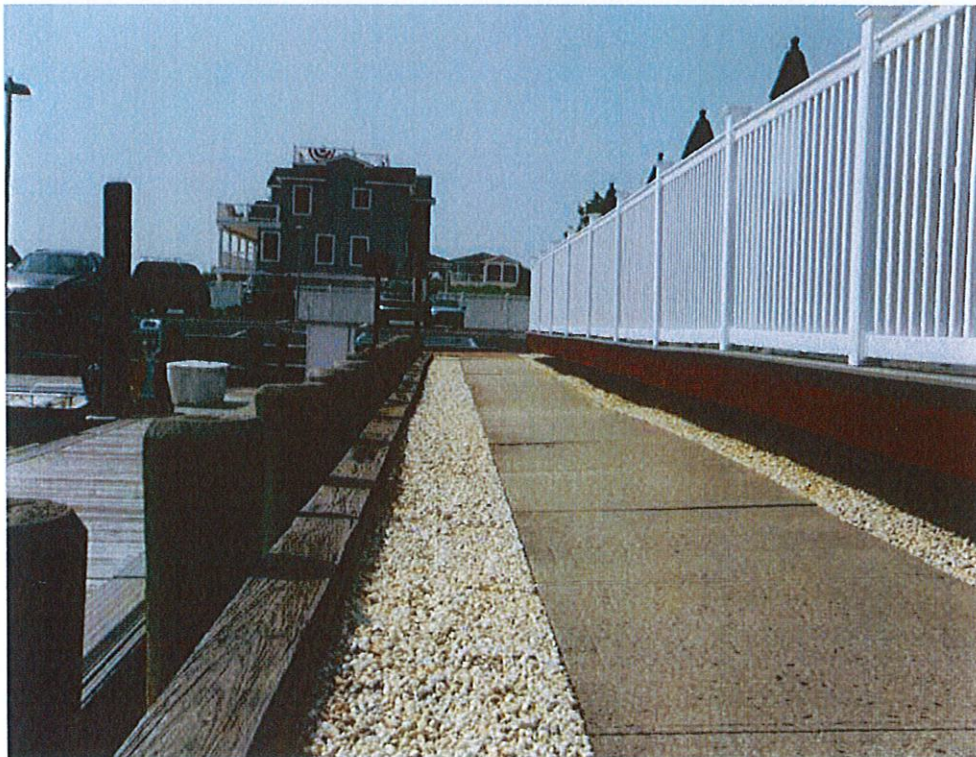
Photo 18: Looking south along the bulkhead and pool deck with subsided walkway

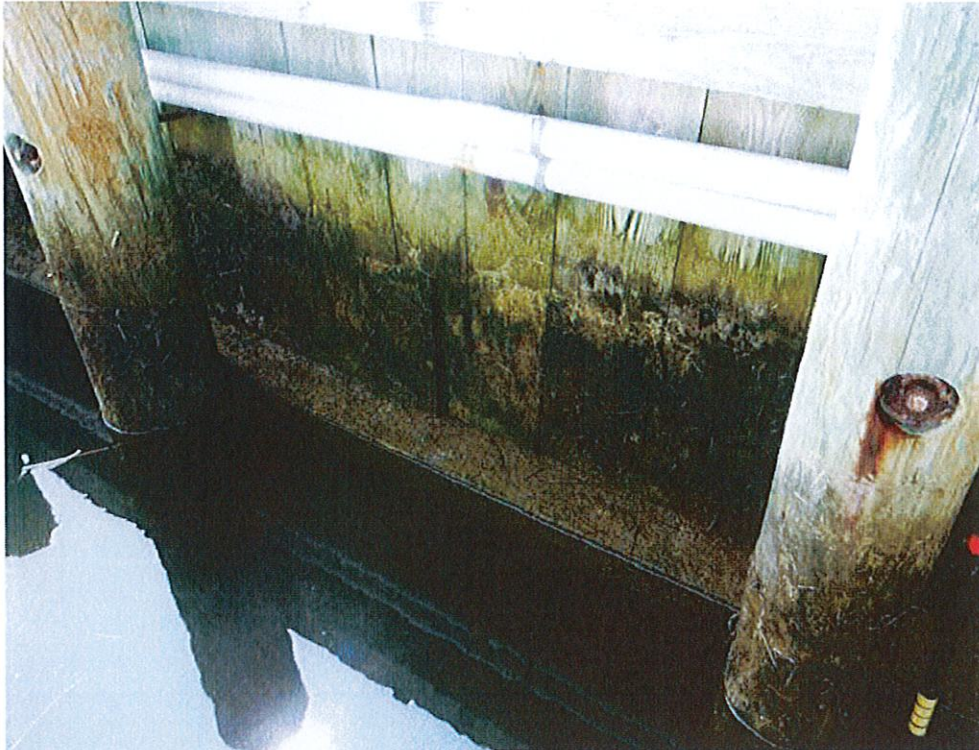
Photo 24: Plywood patches on bulkhead near the south end of G Dock

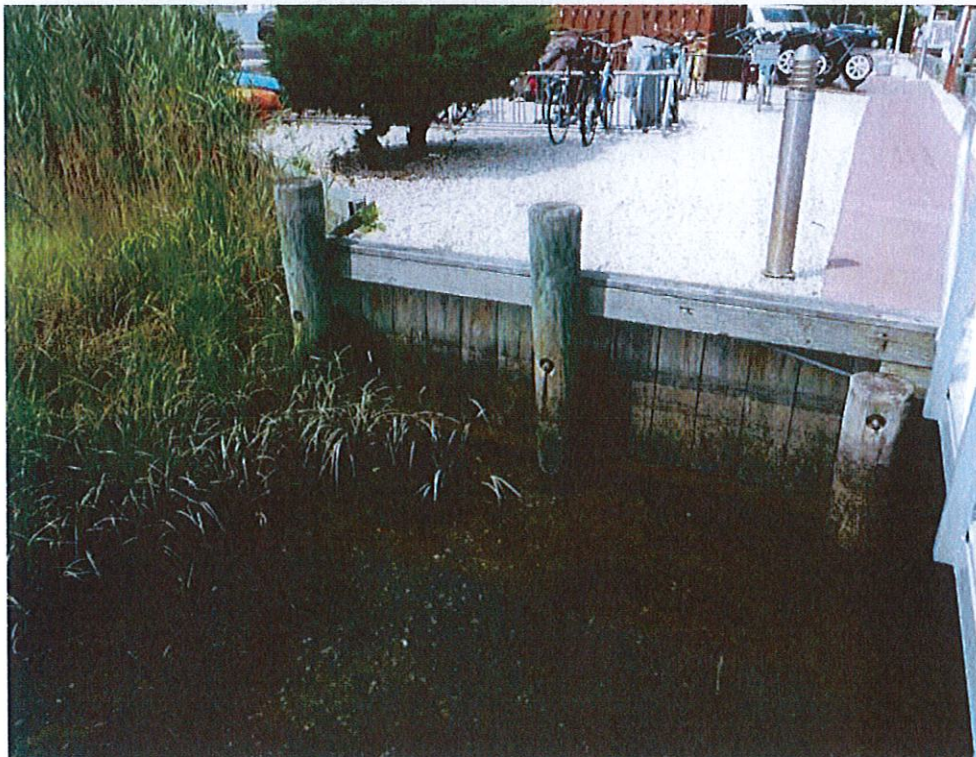
Photo 25: View of the south bulkhead return

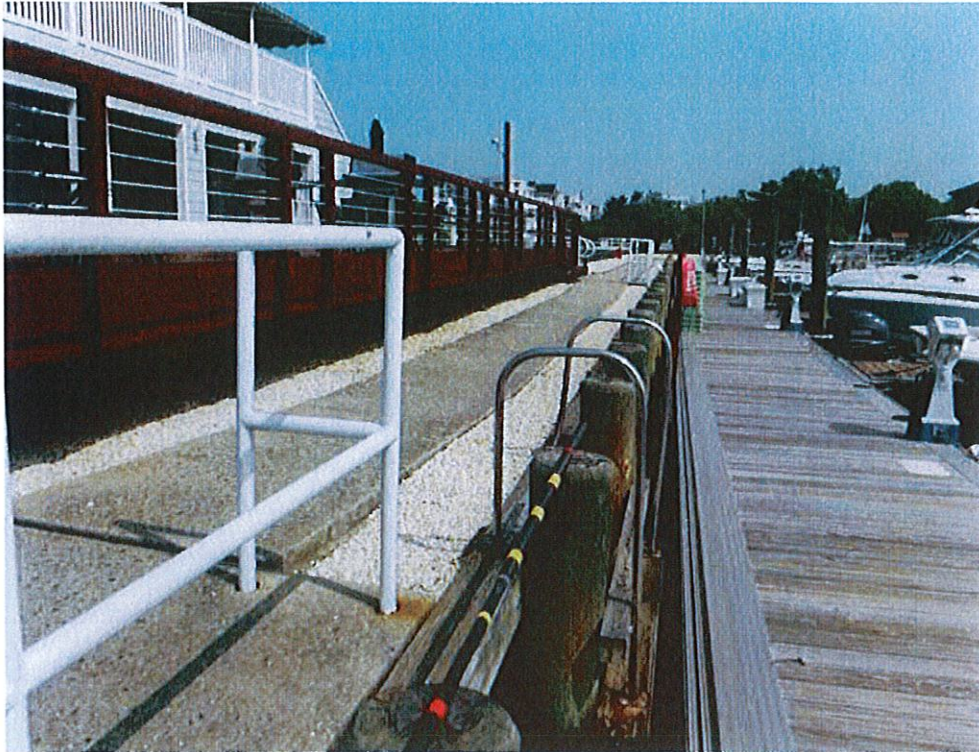
Photo 26: Looking south along the bulkhead and club house deck

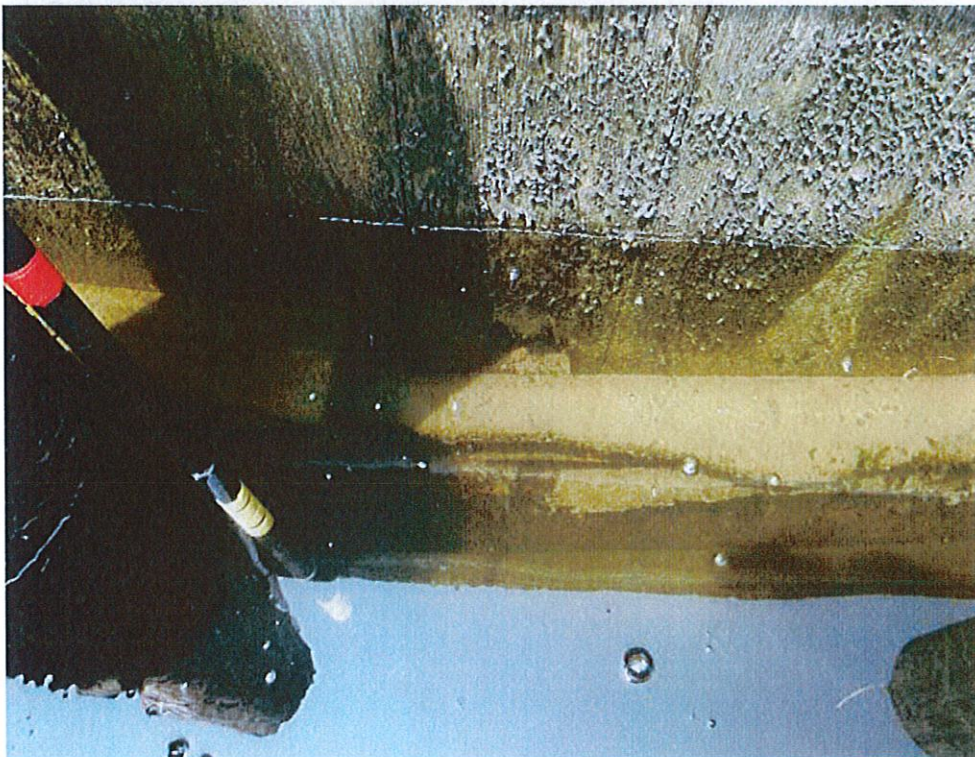
Photo 27: Wale with 70% section loss and hole in sheet pile near slip F Dock Slip 6
